DOWNSTREAM FISH MIGRATION ALONG THE LOW MEUSE RIVER

Action C2

Operation report of the bubble barrier during 2019 migration periods

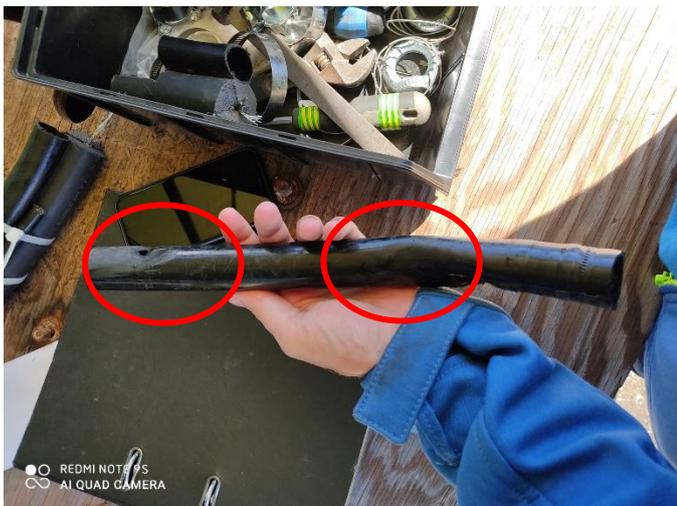
The malfunction highlighted was a poor distribution of bubbles during use. This suggested either a tear or poor pressure distribution. The tears was probably caused by debris and by friction with the concret.

The bubble barrier installed on Ivoy-Ramet has shown a very poor reliability. After many checks, the malfunctioning is clearly linked to the quality of the pipes where several breaches on the pipe appeared (see pictures below). Indeed, despite our efforts to repair the pipes the effectiveness of it couldn't be demonstrated. The constructor gave no guarantee of efficiency.

Breach and deformation of the air supply pipe

A dispute with the supplier also occurred due to the very bad quality of the product. Indeed, we had to pay for the installation of the system 160.513,75€. Moreover, we had to replace some parts and repair the pipe. We engaged 9.927,39€ in supplement. In addition, we had to mobilize our team to follow the works for the installation and to try to make the barrier work.

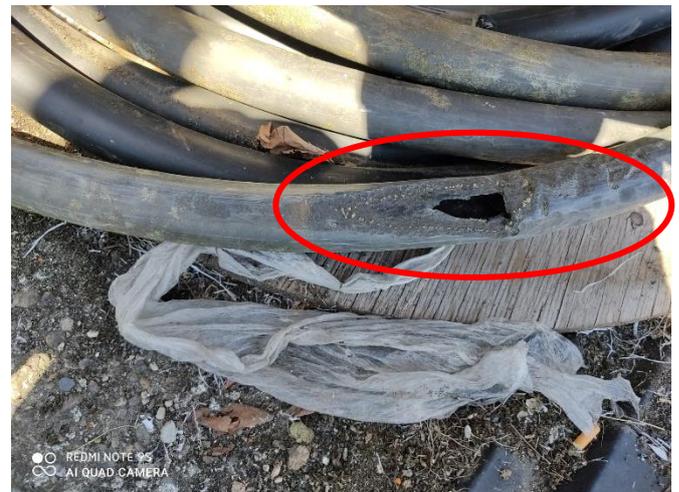
In the second pilot site of Ivoy-Ramet, the bubble barrier has been started on the 20th September 2019. Due to an increase of discharge of an annual amplitude, the bottom air pipe has been destroyed in a short delay (less than a month).

Damage to the bubble pipe at the bottom of the river
