Project: Life4Fish project	Luminus	
Version: V0	Rue du Pont du Val, 1 4100 Seraing ☎ + 32 (4) 330 47 80 - 📠 + 32 (4) 338 24 03 pierre.theunissen@edfluminus.be	Contact name: Pierre Theunissen

DOWNSTREAM FISH MIGRATION ALONG THE LOW MEUSE RIVER

Installation of second electrical barrier for smolts on the site of Grands-Malades

Deliverable – On site installation report

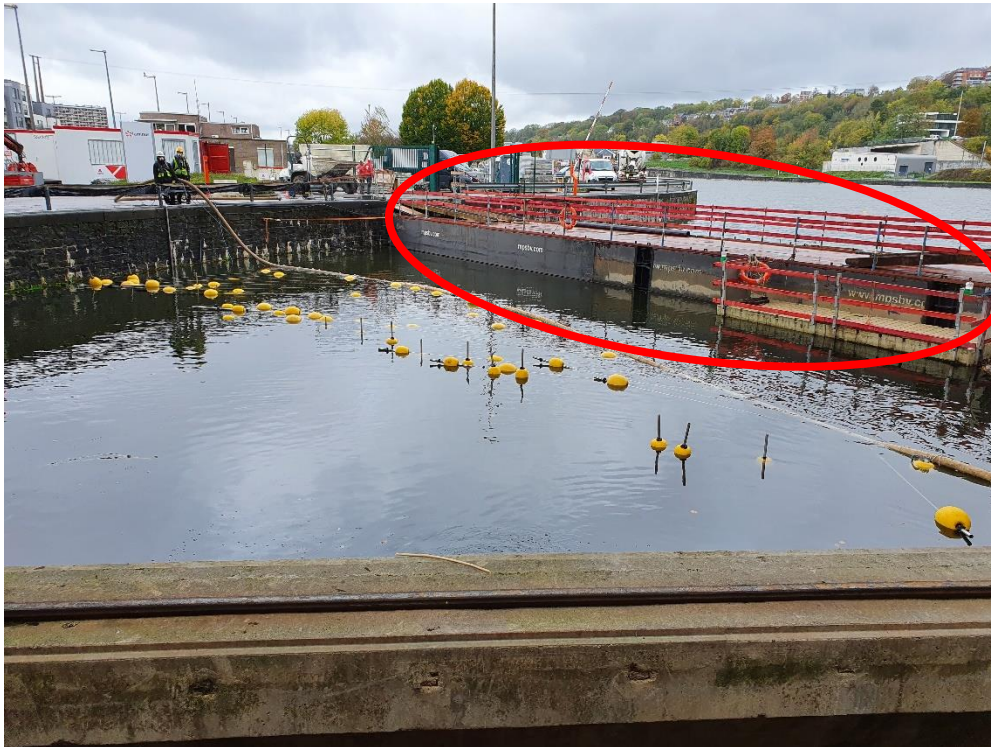
Figure 4 : Artes Plateforme

We had to deal with the platform of Artes, which was the other company on site, because PROCOM wanted to switch on the eels barrier to check if everything work. But the employees of the powerplant told us that two pipes of this barrier were probably touching the platform. To avoid any accident due to electricity we decided to make the test after the end of work day od Artes.

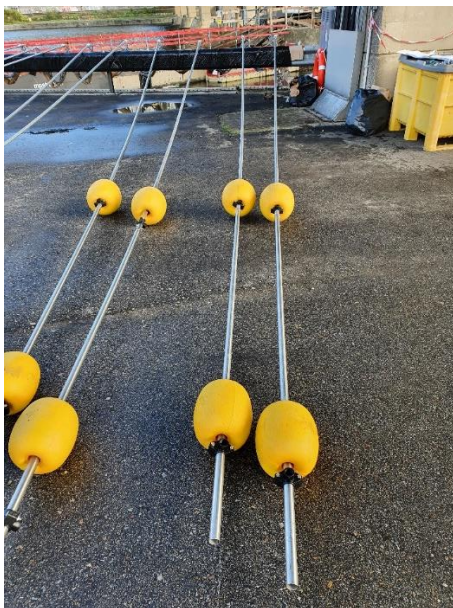
Figure 6: Pipes of 9.7m

The barrier was already present on the site because PROCOM brought it when they installed the eel barrier. we were worried about the depth of the water where the barrier has to be fixed. We asked PROCOM to bring extensions. Due to the slope the depth was increased and the top of pipes were no long enough to be on the surface. The pipes present on the site had a length of 7m but the deep of the water on some areas was until 9.7m (figure3).

The electrodes are made in stainless steel pipe (figure 4). The shackles are fixed to the electrodes via a plastic part made for the isolation. The standard length of pipe was 7 meters so where the electrodes needed to be longer, they were extended. To proceed, they drilled holes and installed the extensions then fixed them with bolts (figures 4 and 5).

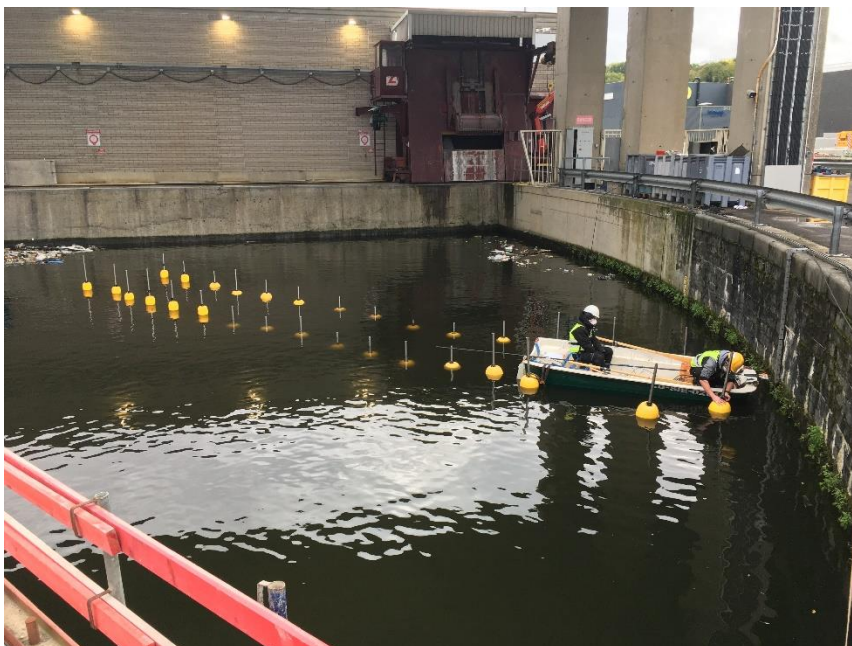
Figure 12: PROCOM are correcting the height of the buoys

For the second barrier, even with the extensions, the ones closest to the fish path were still too short. The divers had to add chain links. Then we put a boat into the water and Procom has adjusted the height of the buoys to be at the correct height.

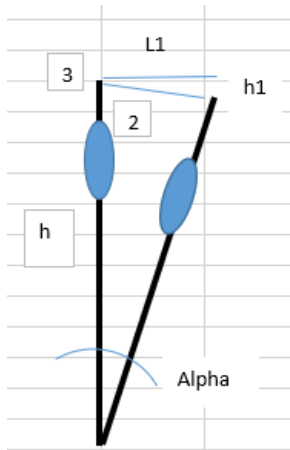
Figure 13 : Inclination of the pipes due to the operation of the turbines

After installing the first barrier on Wednesday 28th and restarting the installations, we were worried about the inclination of the electrodes due to the operation of the turbines.

On Thursday 29th when we arrived three electrodes were no longer visible after having stopped the turbines and a member of the staff of the power station told us that he heard a metallic noise.

We sent the divers to find the missing pipes. Two were lying down and stuck in the grid. After moved both we decided to cut the nearest pipes to prevent that happen again.

We calculated the inclination of the pipes and cut accordingly the new longer to be sure it will be no stuck anymore in the fence. We were worried because without these pipes the barrier will not have the same impact but we decided to not risk any damage on the power plant.
