DOWNSTREAM FISH MIGRATION ALONG THE LOW MEUSE RIVER

Operation report of the electrical barrier and the exhaust path during 2021 migration periods

Deliverable – Operation report during 2021 migration periods

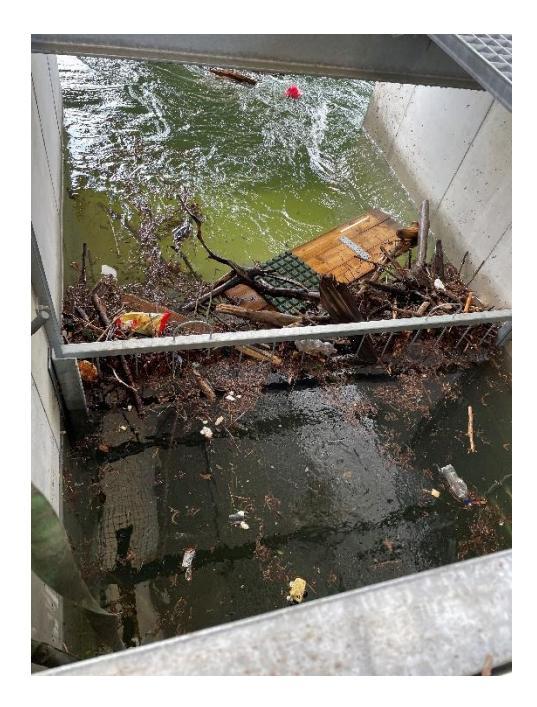
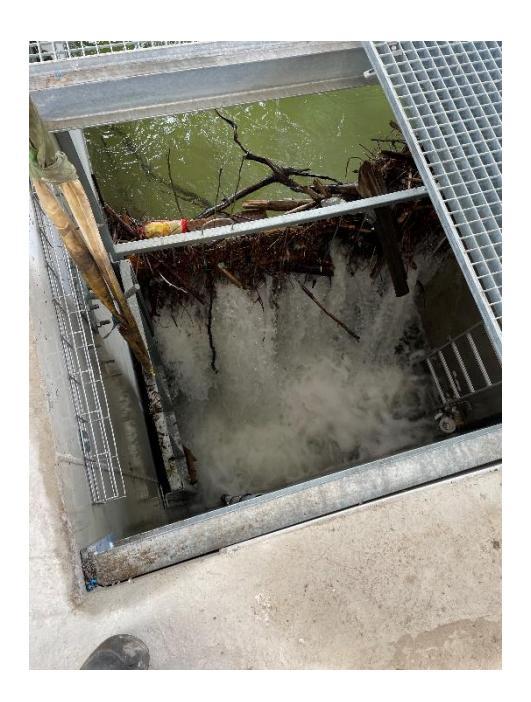
The grid into the entry of the exhaust path was blocked quickly. The water flow was weak and the amount of trash could create passage problem for the smolts. In less than 12 hours we have recorded decrease of 50% of the water flow.

Grid full of trash

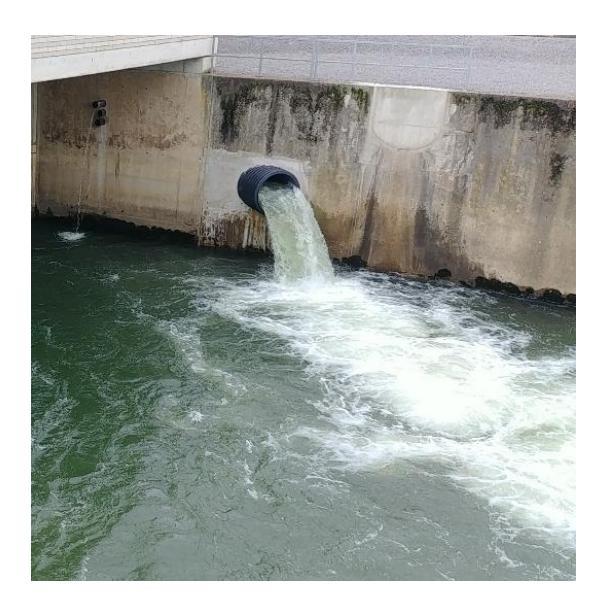
The trash decrease the water flow

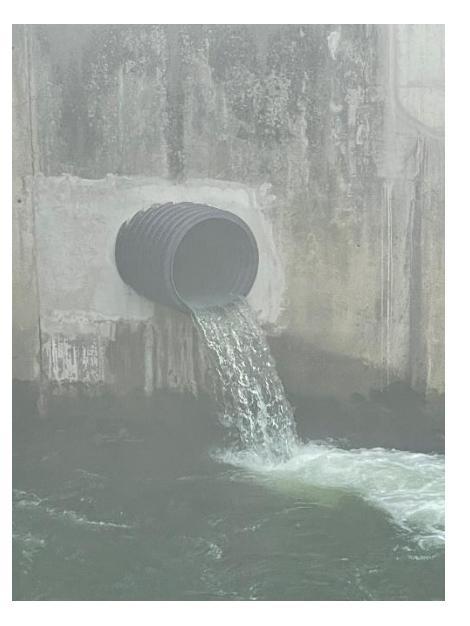
Water flow reduce by trash

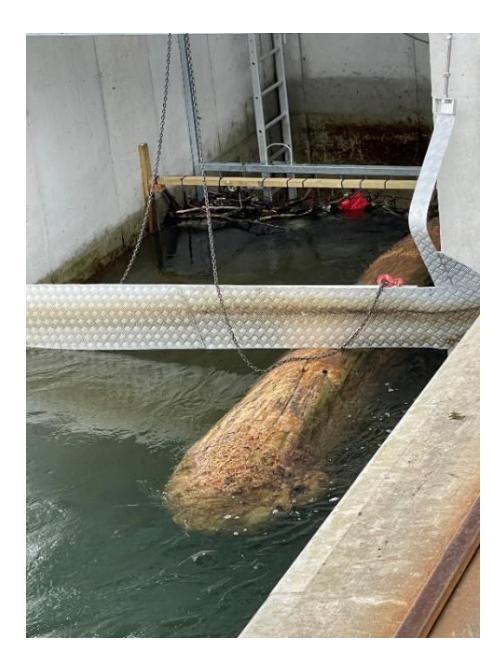
Unfortunately, with the important water flow and the actions of the turbines a whirlpool was created in front of the outlet and the waste went under the blade. Moreover large trunks have damaged the blade and sometimes lifted it. The blade didn't resist after the migration period. The electrical barrier was also damage because, a float from on the second line of electrode has been detached due to the trashes and water flow.

The blade couldn't resist to trunks

With the partners we worked on a new system of grid and blade more resistant and it will be installed in 2022 in order to reduce the problem without any impact on the smolts migration. The cost of this solution will be in charge of Luminus and not put on the Life. This shows that we want to make the investment sustainable.

This grid shall consist of vertical bars 10 cm wide and 10 mm thick spaced at 75 cm intervals. These vertical bars are completed halfway along the length by a horizontal bar 10 cm wide and 10 mm thick.

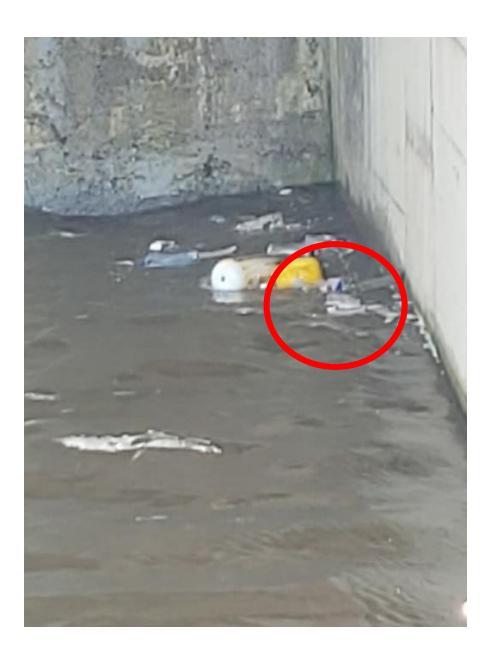
Yellow float from the electrode

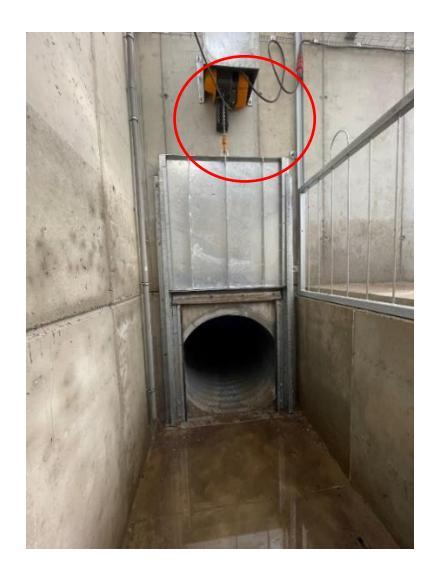
The section of the valve was smaller than the diameter of 1.20m and the hoist was too weak (500 kgs) to close it. We had to use a crane (1.5 t) to close and open it. Due to the supply of material, the gate was managed during the 2021 migration without impacting the results of the downstream migration.

Hoist of the valve

In order to control the activation period of the outlet and allow maintenance operation, a valve has been installed at the entry of the pipe. It is also useful to cut off the flow and allow the operators to clean the trashes screen at entrance. This valve is manual and requires an operator to open and close it. Luminus has decide to motorized this valve. The cost will be fully supported by Luminus.

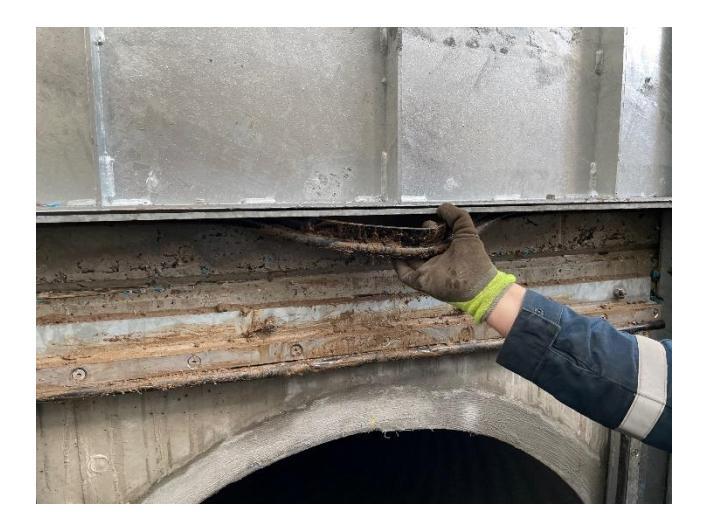
In addition, the valve could not close all the way. The gasket had to be replaced because it was not positioned correctly and was letting water through. It could be replaced by the subcontractor before the start of the downstream migration.

Valve gasket is not positioned correctly view 1

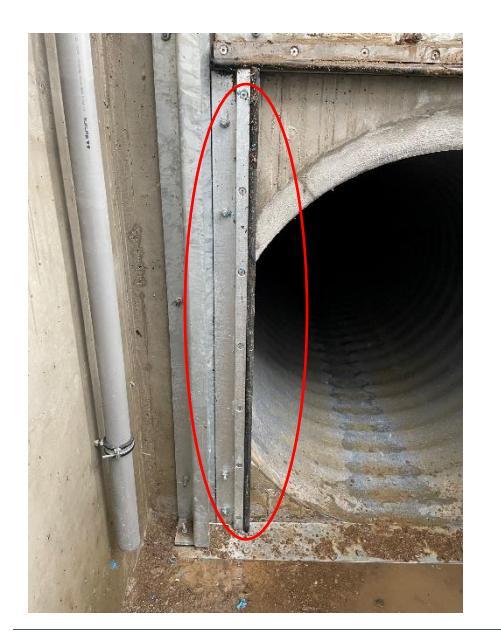
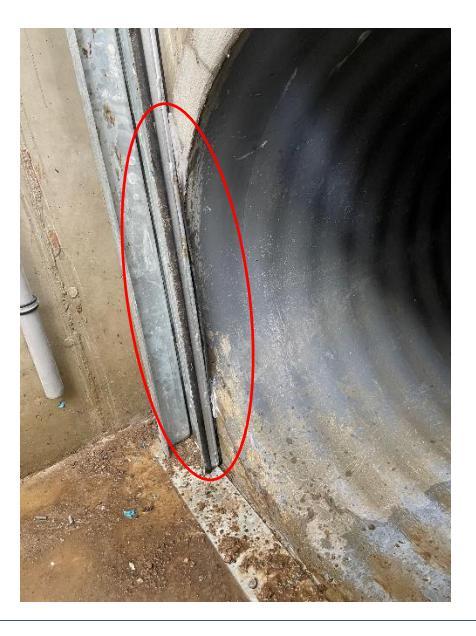
Valve gasket is not positioned correctly view 2

Valve gasket is not positioned correctly view 3

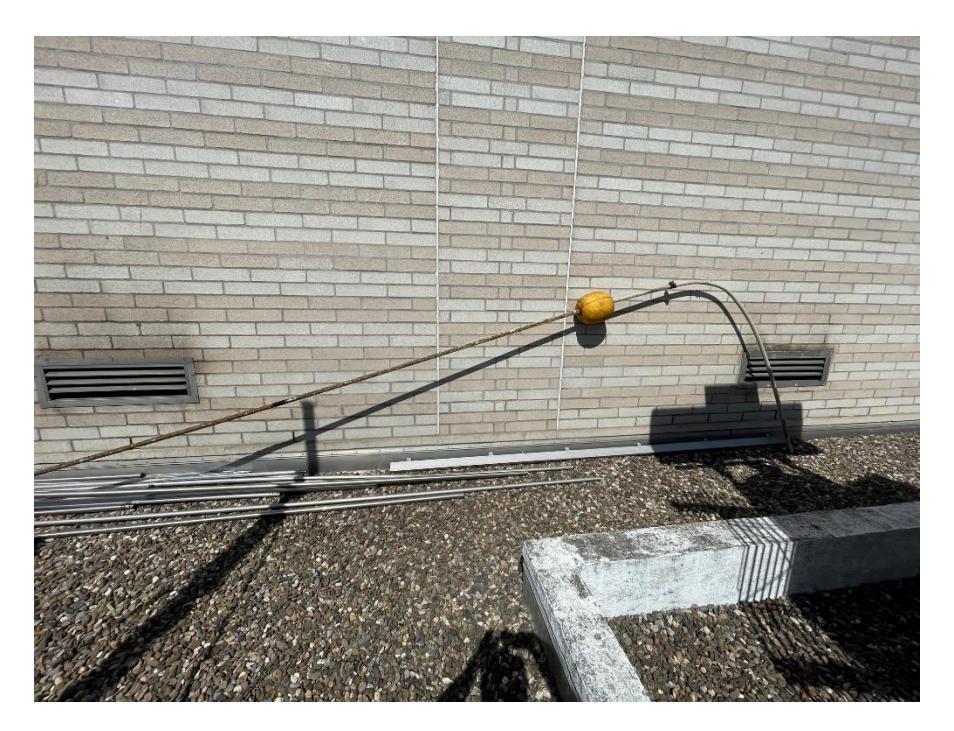
Few weeks after the end of the smolts migration we had the sent the divers inspect the second row of the barrier due to a signalment of the operators of the powerplants. The pipe of 7 meters was twisted on the 2.5 meters. The trashes probably laid down the electrode until the trashes cleaner and during the cleaning of the powerplants grides the crane damaged the electrode. Diver team finally replaced it.

Electrode number 5 twisted probably by the trash cleaner

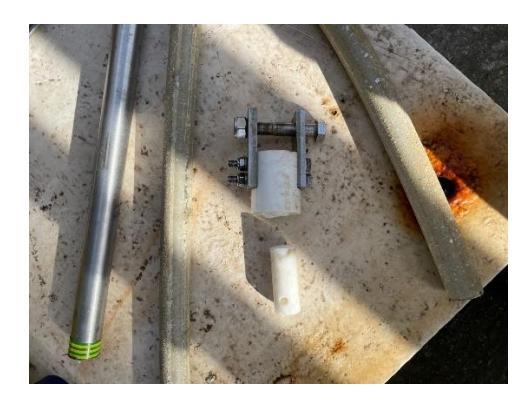
The last electrode, the closest from the mole, was damaged by trashes or waterflow. It was only maintained by the blue electric cable and not any more by the white ertalon part. The diver team removed the broken piece and replaced it by a new one. After this incident we asked to Procom to send us more spare parts.

Ertalon breaked
