DOWNSTREAM FISH MIGRATION ALONG THE LOW MEUSE RIVER

Operation report of the electrical barrier and the exhaust path during 2021 migration periods

Deliverable – Operation report during 2021 migration periods

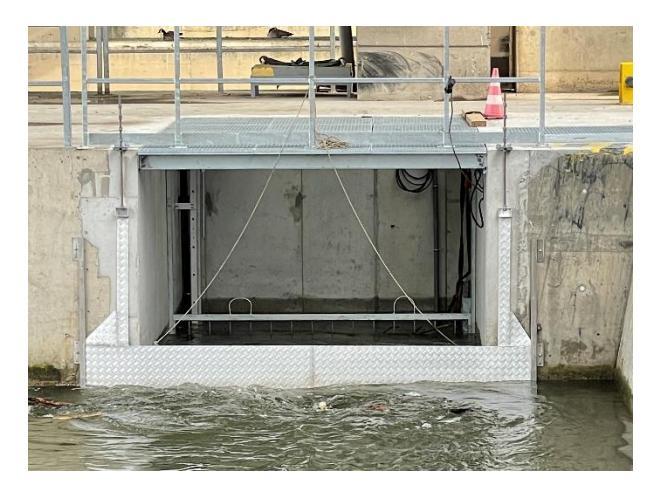
Metallic blade at the entry of the outlet

Unfortunately, with the important water flow and the actions of the turbines a whirlpool was created in front of the outlet and the waste went under the blade. Moreover large trunks have damaged the blade and sometimes lifted it. The blade didn't resist after the migration period. The electrical barrier was also damage because, a float from on the second line of electrode has been detached due to the trashes and water flow.

With the partners we worked on a new system of grid and blade more resistant and it will be installed in 2022 in order to reduce the problem without any impact on the smolts migration. The cost of this solution will be in charge of Luminus and not put on the Life. This shows that we want to make the investment sustainable.

This grid shall consist of vertical bars 10 cm wide and 10 mm thick spaced at 75 cm intervals. These vertical bars are completed halfway along the length by a horizontal bar 10 cm wide and 10 mm thick.

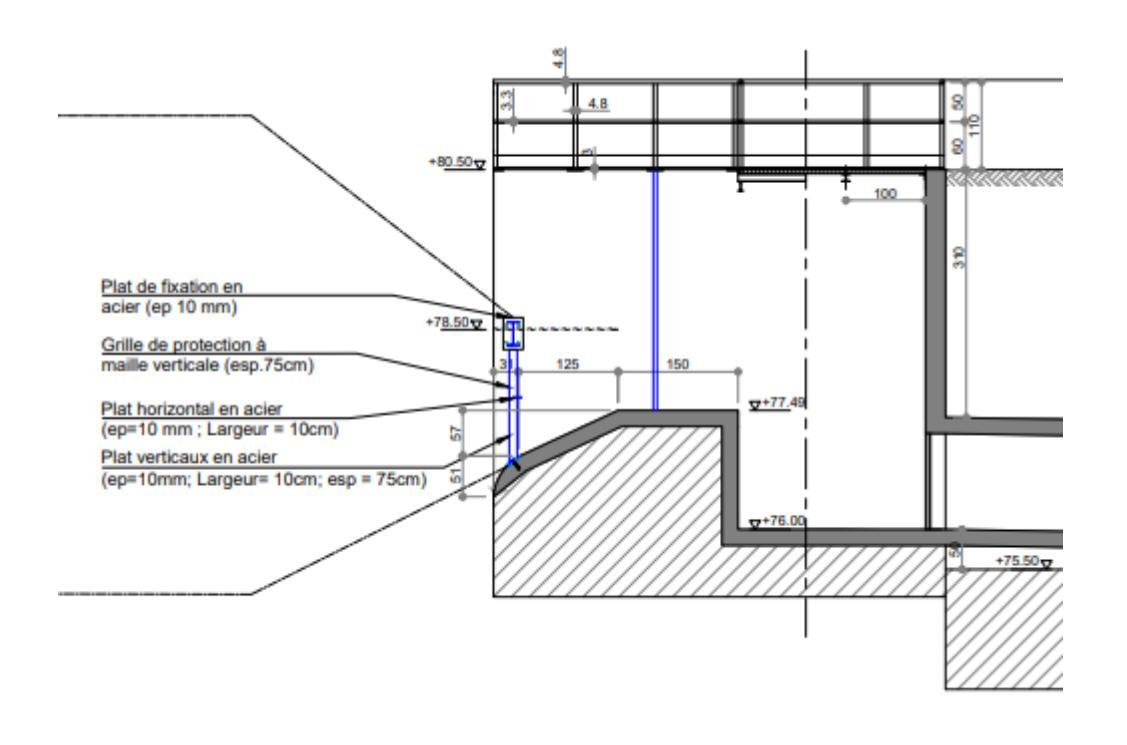
Schematic of the grid

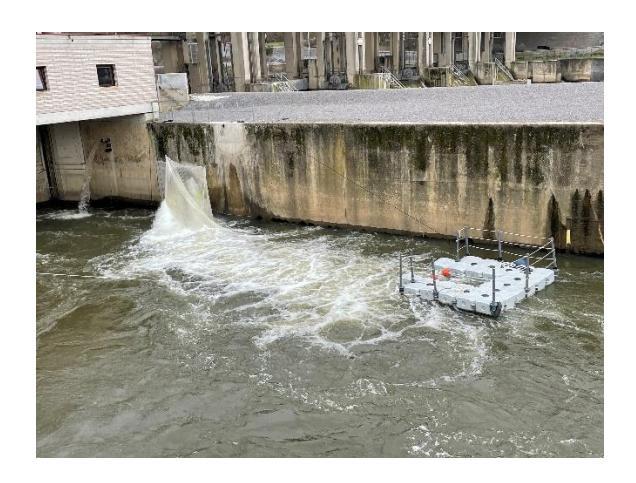
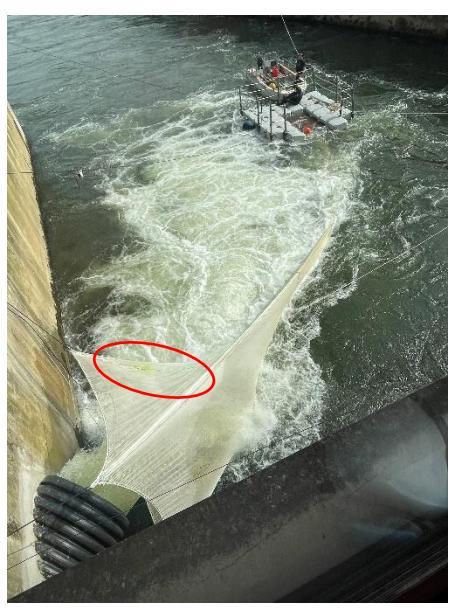
Moreover, the trashes caused many troubles during the monitoring made by Profish during spring migration. They placed a net at the exit of the outlet to capture smolts after their passage into the pipe. Unfortunately many trashes did the same and after few days, Profish had to repair the net many times. We had to stop the groups for an hour to secure the equipment and the Profish team.

Net and platform

Profish's team working on the plateform

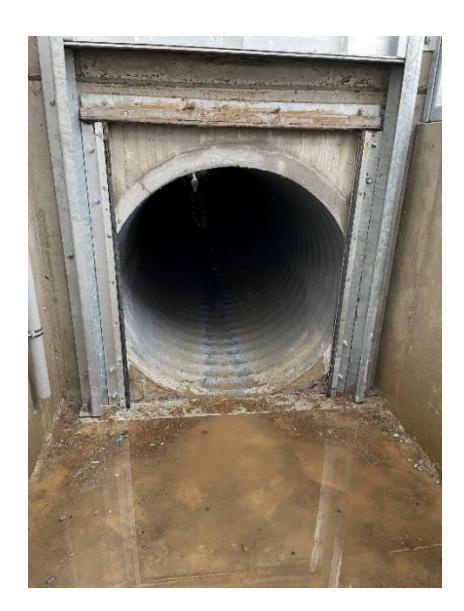
In addition, the valve could not close all the way. The gasket had to be replaced because it was not positioned correctly and was letting water through. It could be replaced by the subcontractor before the start of the downstream migration.

Valve at the outlet entrance

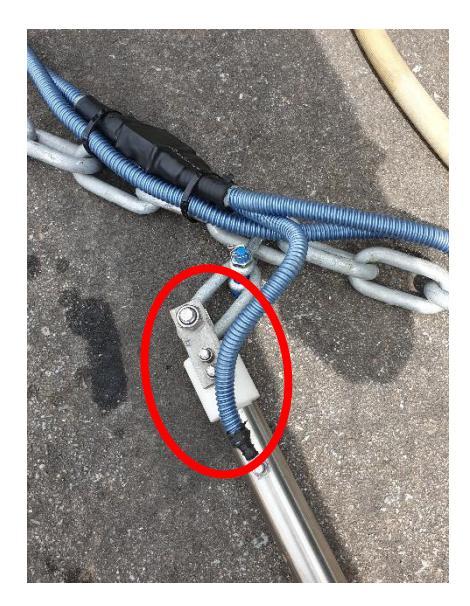
The last electrode, the closest from the mole, was damaged by trashes or waterflow. It was only maintained by the blue electric cable and not any more by the white ertalon part. The diver team removed the broken piece and replaced it by a new one. After this incident we asked to Procom to send us more spare parts.

Ertalon intact before installation
