Project: Life4Fish project	Luminus	
Version: V0	Rue du Pont du Val, 1 4100 Seraing ☎ + 32 (4) 330 47 80 - 📠 + 32 (4) 338 24 03 pierre.theunissen@edfluminus.be	Contact name: Pierre Theunissen

DOWNSTREAM FISH MIGRATION ALONG THE LOW MEUSE RIVER

Installation of second electrical barrier for smolts on the site of Grands-Malades

Deliverable – On site installation report

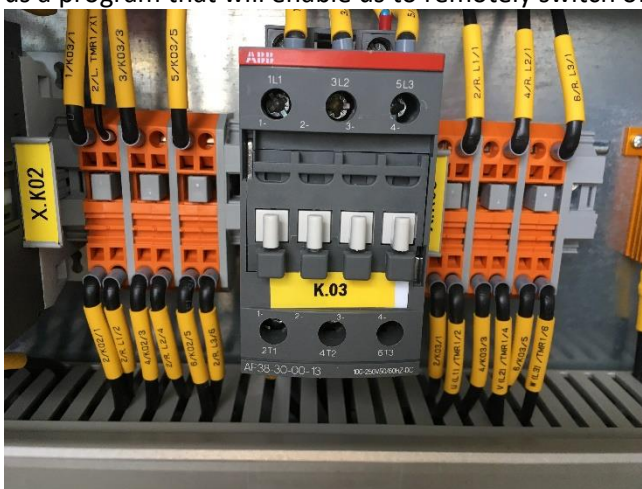
Figure 5 : Section where we have to connect our cable

Electrodes are powered by an electrical cabinet installed by Procom system next to the concrete pills of the bridge. They connected the second barrier to the electrical cabinet already present. We asked them to provide us a signal to allow us to have a state of the three sections of the barrier in distance. They showed us how to connect a cable at the electrical cabinet. They are preparing for us a program that will enable us to remotely switch off and on the barriers.

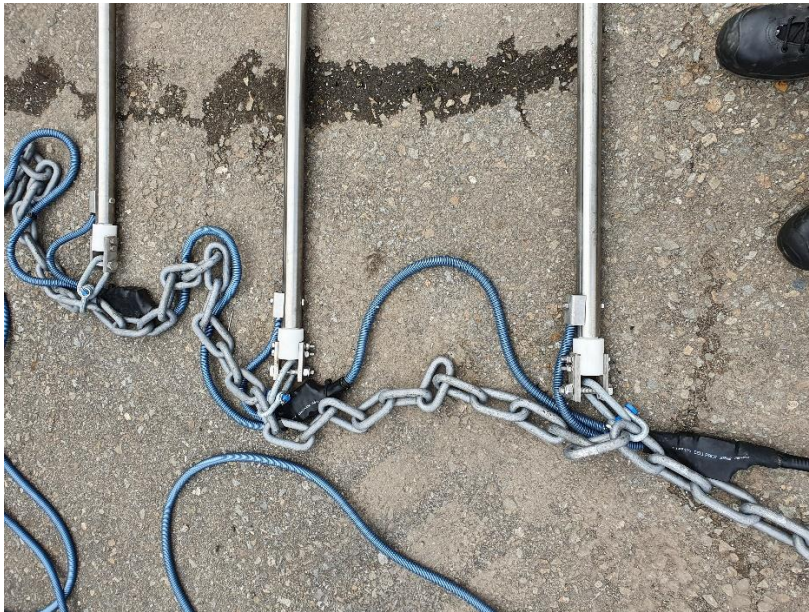
Figure 9 : Pipes with the chain and the electrical cable

Thanks to a galvanized shackle electrodes are fixed to the chain. The electrical connection between the cable is a physical connection, the extremity is locked on a threaded shaft with a screw. A metal cover is ad on the connection to protect the system and in addition to the physical protection, the PUH-255 (sealant) is put inside the metal cover.

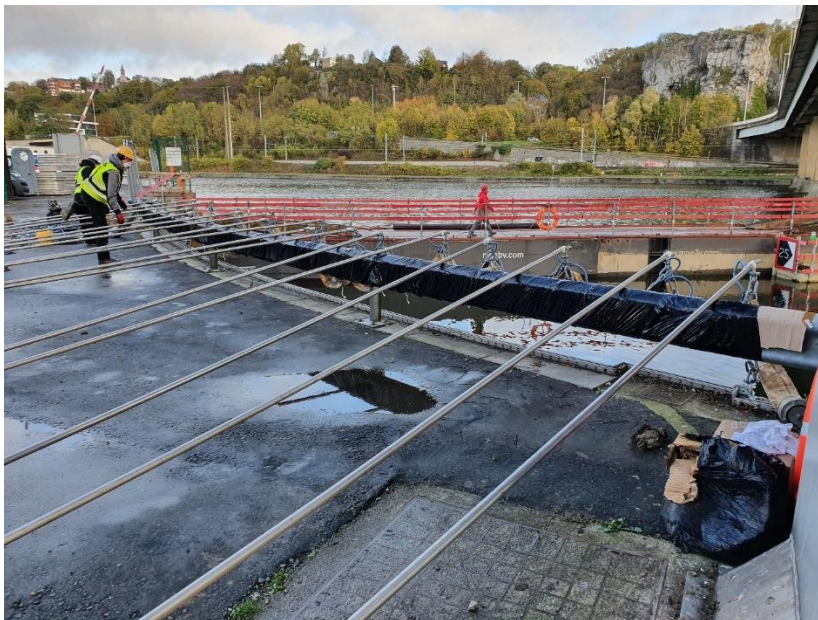
Figure 10 : the first barrier ready to be launch

The fence near the water has been kept this time to prevent the risks of falling into the water. Protection has been installed along the barrier to protect it (in black on the figure 6).

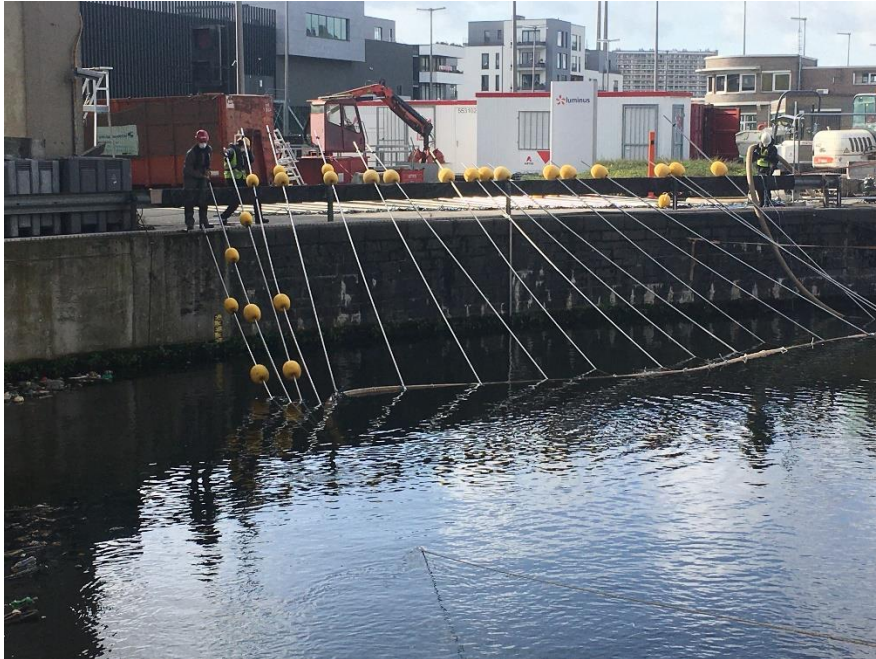
Figure 11 : Launching of the first barrier

Thanks to a water hose fixed in a lot of point on the chain, the whole system was able to float. The water hose is inflated by a small compressor. It make the system easier to move and put in the right position. One extremity was hold with a rope from the other side of the water. Then electrode after electrode we put the system into the water, paying attention that no one is between electrodes in

case of a fall in the water of the whole chain carried away by its weight. Once the barrier is on position, divers cut the rope to make the system drown.

The first barrier, the one with the cathodes was set up without any delay. Divers put shackles to fix the chain to the anchors.

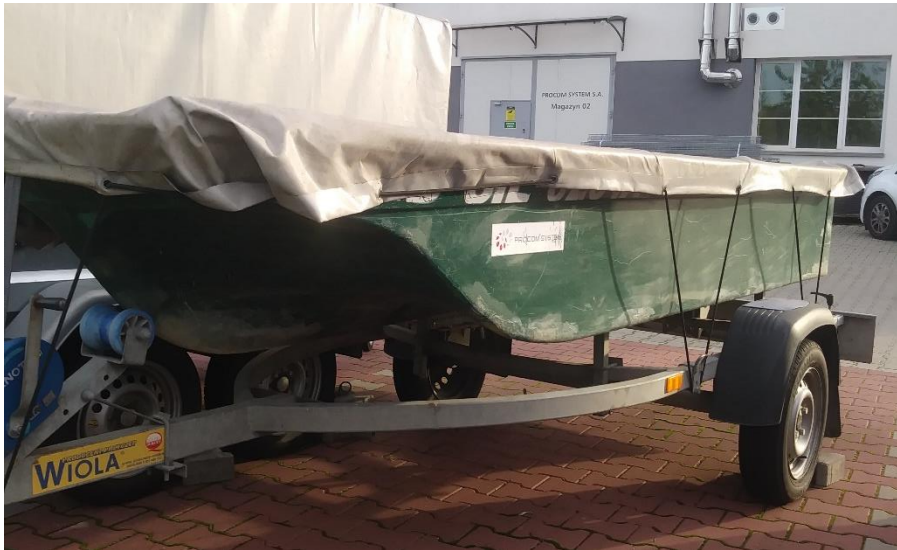
Figure 16 : Boat of PROCOM

This time we asked to PROCOM to come with their own boat.

The measures were good and the insulation finalized without any problem.
